HOMEBUILD
PROPERTY

Quarterly Inspection Report

22 Nov 2017 03:36 PM

Nicholas Stott

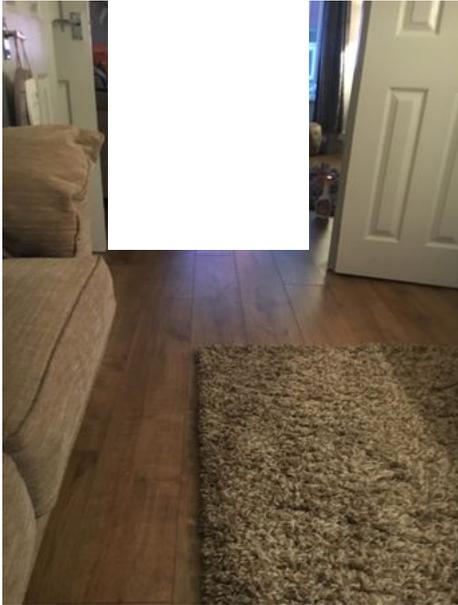
Appendix 1

Question	Response	Details
Property		
Rooms		
Entrance		For the landlord's information (FYI)
		More paint is peeling off the walls. Tenant reporting items of clothing getting mouldy when left in here.
Living Room		LANDLORD REPAIR REQUIRED
		See front of property issue.
<div style="display: flex; justify-content: space-around;"> <div style="text-align: center;">

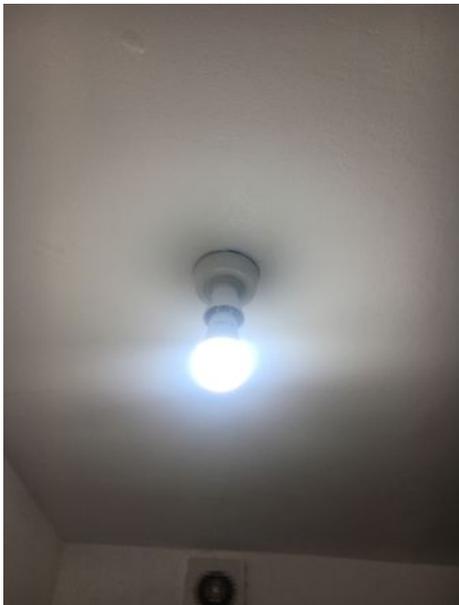
Appendix 7

Question	Response	Details
Appliances		
Is the Oven (& hob) in full working order	Yes - The appliance is in full working order	
Is the Fridge (& freezer) in full working order?	The appliance is the Tenant's own	
Is the washing machine/washer-dryer in full working order?	The appliance is the Tenant's own	
Is the dishwasher in full working order?	N/A	
Bathroom/ W/C		
Bathroom / W.C.	No issues found on inspection, or reported by the Tenant, that require attention.	
Is there a sealed ('zoned') light fitting to keep moisture away from the electrical wiring?	No	
We recommend having a sealed light cover to prevent moisture affecting the electrics. These are approximately £84.00 supplied and fitted.

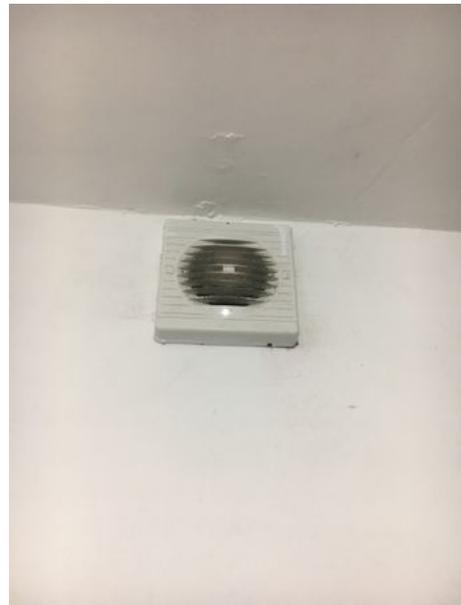
Appendix 8

<p>Appendix 8</p>		
Stairs & Landing	No issues found on inspection, or reported by the Tenant, that require attention.	
Bedrooms		
Bedroom 1	Condensation & black mould was noted. This is a Tenant's responsibility and will need to ensure that the property is being adequately ventilated by opening windows and ensuring extractor fans are on, No issues found on inspection, or reported by the Tenant, that require attention.	
	No black mould growth, but the tenant reports 'damp' dripping off the window sill. Advised that this is simply condensation and to ventilate accordingly.	
Bedroom 2	No issues found on inspection, or reported by the Tenant, that require attention.	
Bedroom 3	No issues found on inspection, or reported by the Tenant, that require attention.	
Bedroom 4	N/A	
General Safety & Compliance Checks

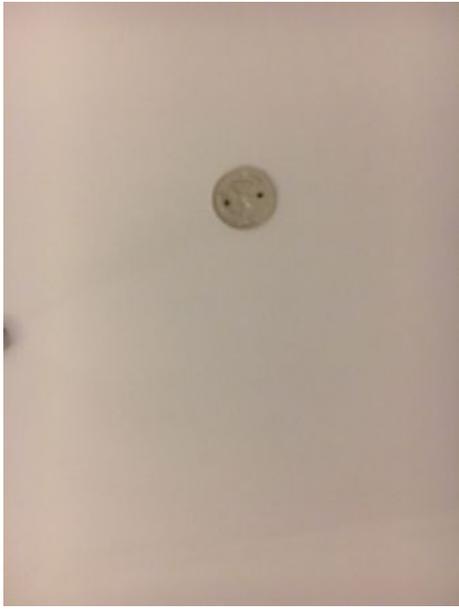
Appendix 9

<p>Appendix 9</p>		
<p>Carbon Monoxide alarm present and fully working?</p>		<p>No - There was no Carbon Monoxide Alarm present at the time of inspection. PLEASE NOTE - Landlords only need to install Carbon Monoxide Alarms in high-risk rooms (such as those with a gas fire, or a solid fuel heating system). However, as gas appliances can emit carbon monoxide, we encourage landlords to ensure that working Carbon Monoxide Alarms are installed in all properties. If you would like Homebuild to arrange for the supply and fitting of one of these then please let us know.</p>
<p>Security Alarm present and fully working?</p>		<p>N/A - There is no alarm present at the property</p>
<p>Fuse Board</p>		<p>The fuse board is being safely maintained</p>
<p>Are there any Fire escape windows (bottom-opening) on the 1st floor or higher?</p>		<p>Yes - Windows meet the current Building Regulations</p>

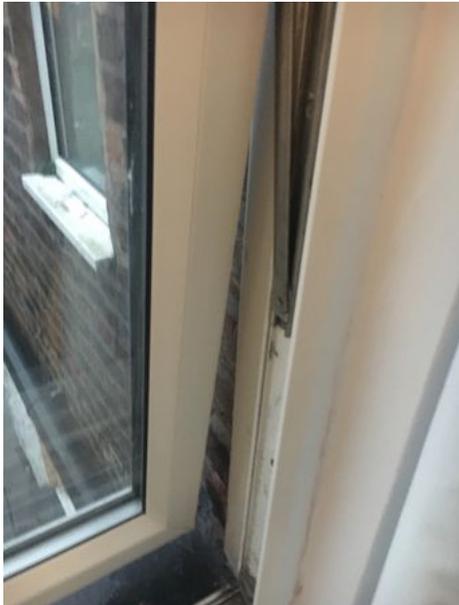
Appendix 11

<p data-bbox="134 434 261 461">Appendix 11</p>		
Window Keys		<p data-bbox="715 524 1485 734">No - Tenant advises they have NOT been given/found any window keys. I have confirmed the TYPE OF KEY required from our master set, which we can post out to the tenant following this inspection. At least 1 window key is required by law, under the Landlord Licensing Conditions.</p>
Utility Meters		
Type of GAS Meter	Pre Paid Meter	
Photograph of meter reading & serial number (where possible)		
Where is the GAS meter?	In the living/front room	
Type of ELECTRICITY Meter	Pre Paid Meter	
Photograph of meter reading & serial number (where possible)		
Where is the ELECTRICITY meter?	In the living/front room	
Exterior		
Front & Rear of Property	LANDLORD REPAIR REQUIRED

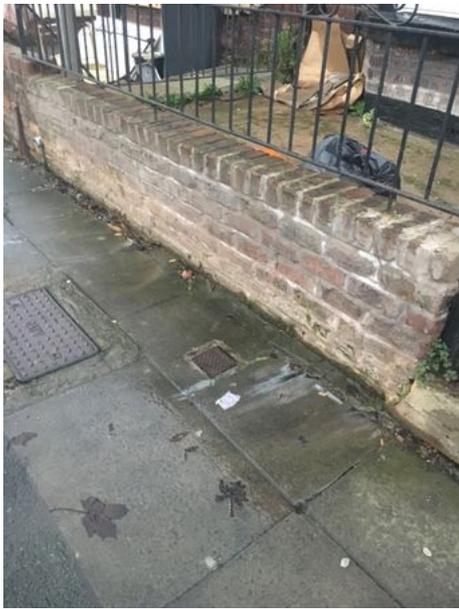
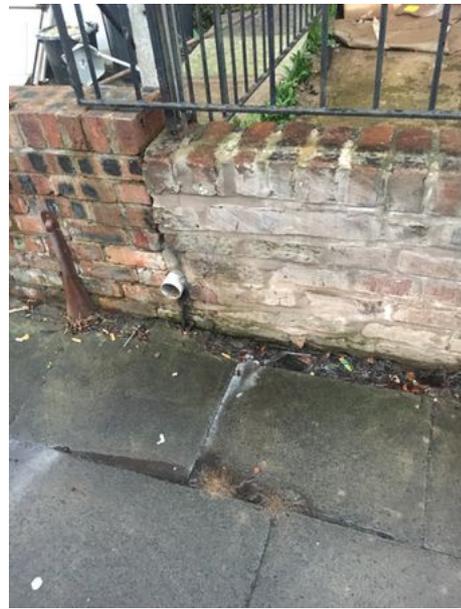
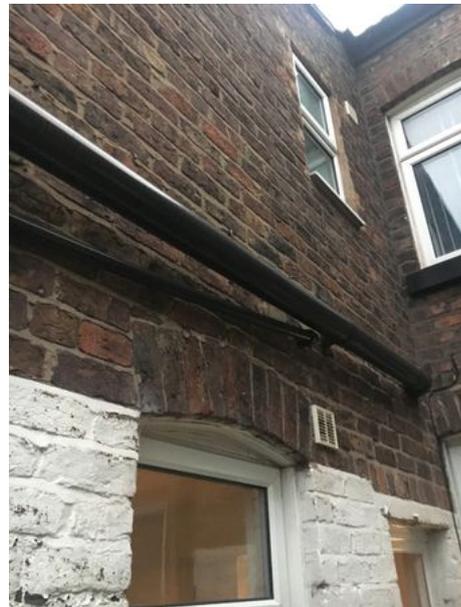
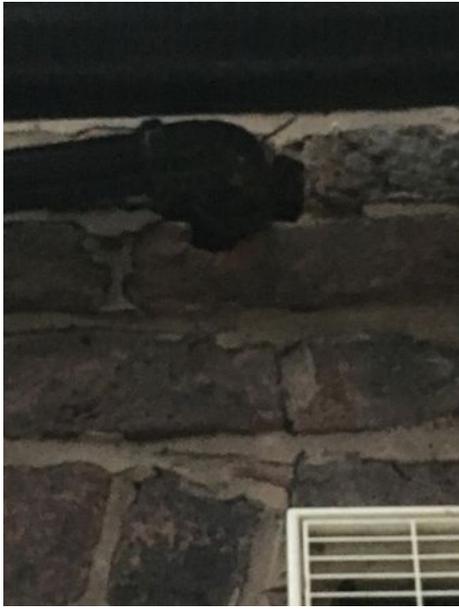
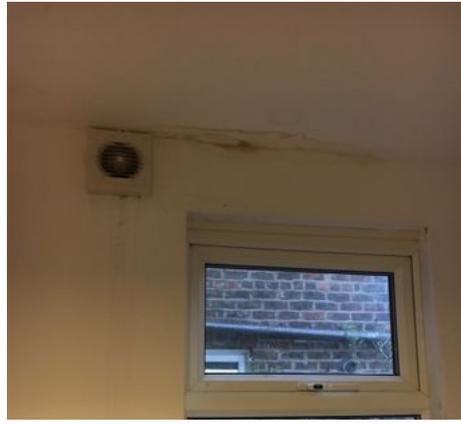
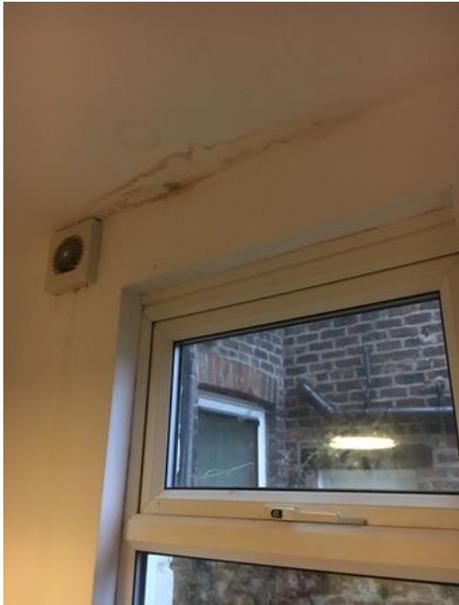
Question	Response	Details
		<p>DAMP: There has been an ongoing issue at this property with 'damp'.</p> <p>At a previous inspection, it was noted that there was standing water in the rear yard. At the front of the property, water was pouring onto the pavement from underneath the front yard.</p> <p>This issue is still ongoing and, if anything, has got worse.</p> <p>The tenant said that she has had United Utilities out to try and identify the cause. They put coloured dye down the internal drains but nothing entered the external drains, so that would suggest that this is an external issue.</p> <p>To the inside, the kitchen vinyl has blown and is now bobbled throughout the room.</p> <p>The laminate floor in the dining room - and through to the living room - has started to warp on the edges. Although this may have been caused by a wet mop, it may also be a sign of a leak beneath the floor.</p> <p>It is fairly common to have high water tables in this area which cause mean that the ground underneath the whole property is wet and, when it rains, large amounts of rainwater may be flowing underneath the whole house.</p> <p>Having had this happen to one of my own properties, I strongly recommend having this investigated thoroughly.</p> <p>Separately, an unrelated penetrating damp spot is occurring above the side elevation window in the kitchen. I suspect this is due to an unsealed waste pipe on the outside (coming from the bathroom).</p>
